Contract No. CON00008697
Study No 10001550
Final Report

Corrosion in Systems Storing and Dispensing Ultra Low Sulfur Diesel (ULSD), Hypotheses Investigation

Battelle Memorial Institute
505 King Avenue
Columbus, OH 43201

Final Report

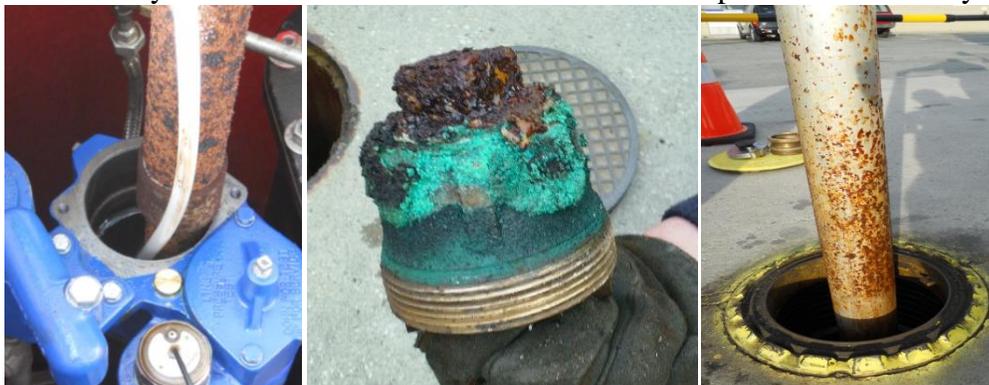
Figure 1. Corroded ULSD equipment: Corroded carbon steel submersible turbine pump (STP) shaft removed from pump housing, CA-1 (left), brass ball float extractor cage plug, NY-2 (middle), aluminum drop tube, NC-1 (right).

From as early as 2007, the Petroleum Equipment Institute (PEI) started receiving reports of unusually severe and accelerated corrosion of metal parts associated with storage tanks and equipment dispensing ULSD. Reports include observations of a metallic coffee ground type substance clogging the dispenser filters and of corrosion and/or malfunctioning of seals, gaskets, tanks, meters, leak detectors, solenoid valves and riser pipes. These observations were reported to be occurring in as little as 6 months. The corrosion was reported on the unwetted, or ullage, portions of the tanks and equipment in addition to the wetted portions of UST equipment. Figure 1 shows representative pictures of ULSD system components with rust-colored deposits as reported from industry stakeholders and as found at retail sites inspected for this study.

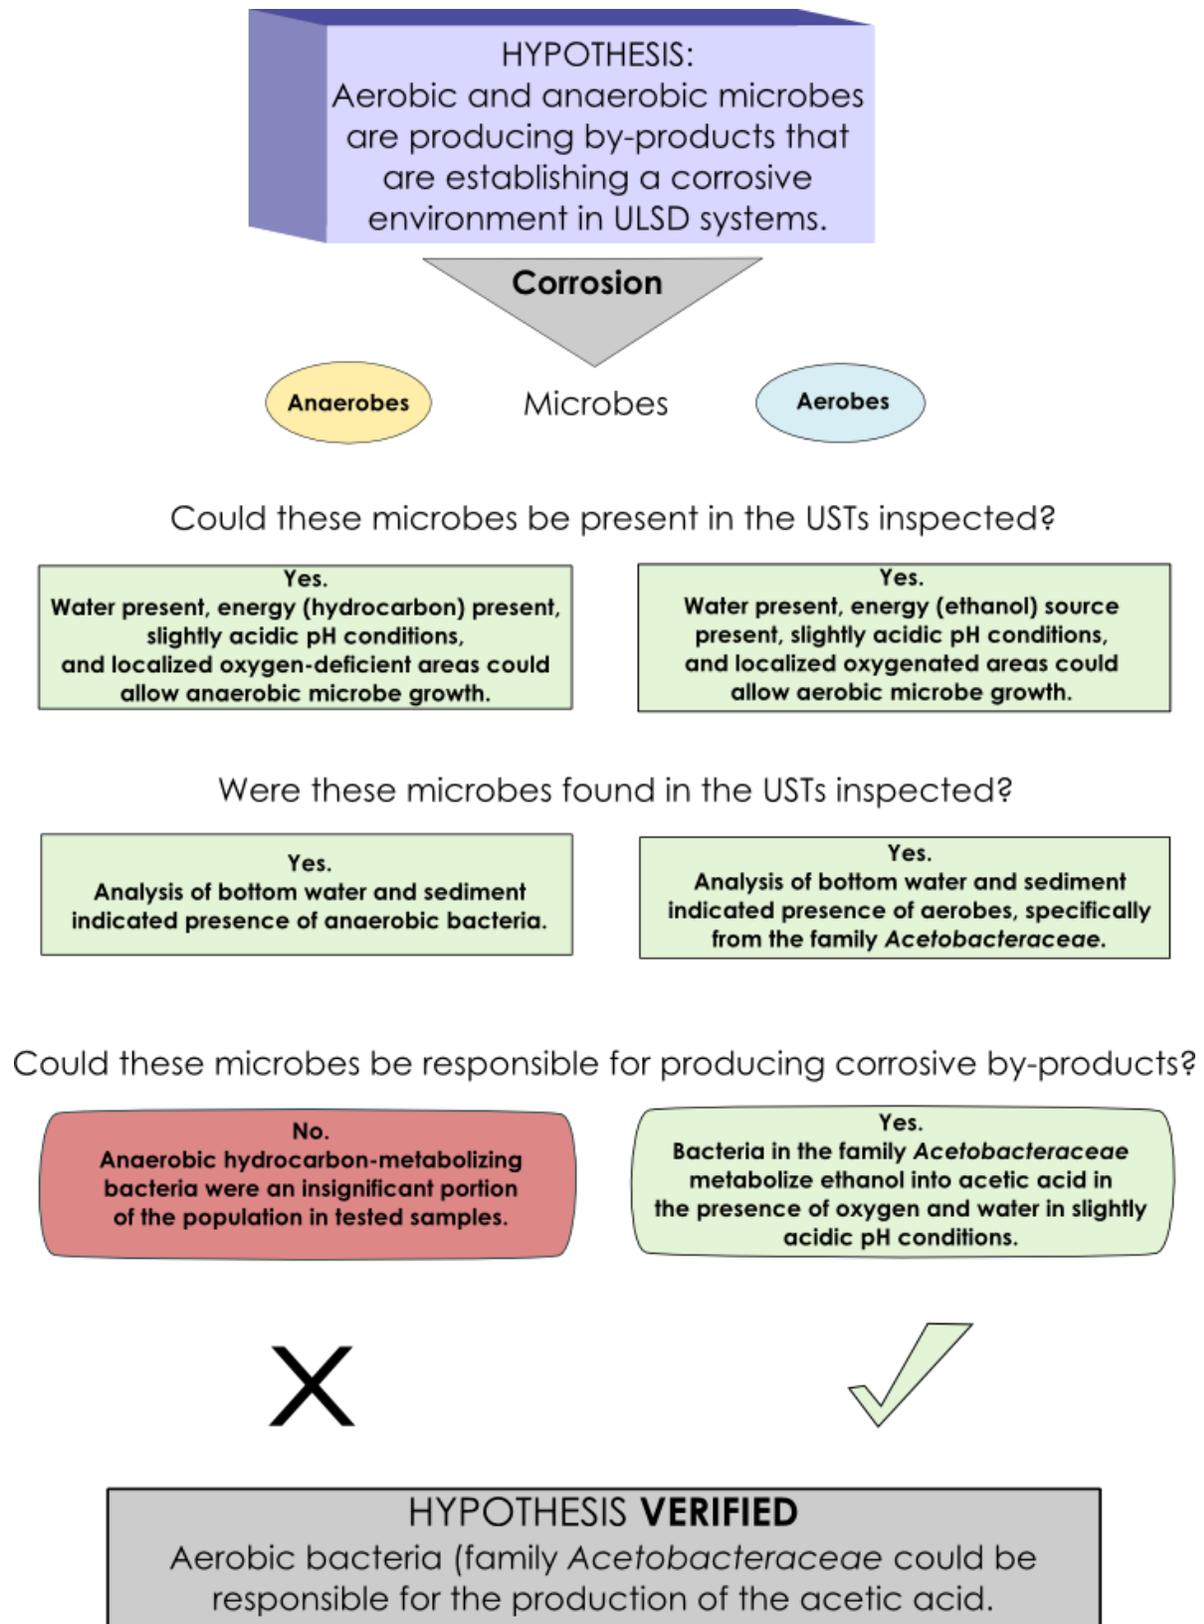
Figure 4. MIC Hypothesis Evaluation

All of the sites inspected in this research project contained microbes, although at different abundances. The dominant organisms identified from three of the sites have characteristics pertinent to the corrosion observed in all of the sites, such as acetic acid production, ethanol utilization, low pH requirements, environmental presence, and oxygen. Although geographically on opposite sides of the country, with different fuel supplies and from relatively new construction materials, the presence of the organisms was relatively uniform. The traditionally expected organisms were found in insignificant abundances. Anaerobic organisms ranged from 0% to 6% and hydrocarbon degrading organisms from the *Gammaproteobacteria* class ranged from 0.3% to 5% in the samples analyzed. This indicates that ULSD USTs are selective environments for these specialized, acetic acid producing organisms. Therefore, as shown in Figure 4, the microbial hypothesis is accepted with respect to aerobic microbes but rejected with respect to anaerobic microbes.

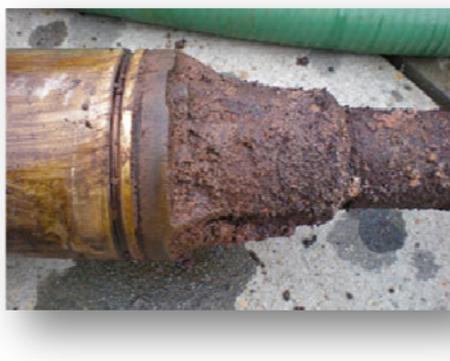
Figure 2. Example of observed corrosion.
